Reference
PX05884-02

Fire test of a facade cladding

SP FIRE 105, issue 5, dated 1994-09-09

Teknos FR Facade cladding

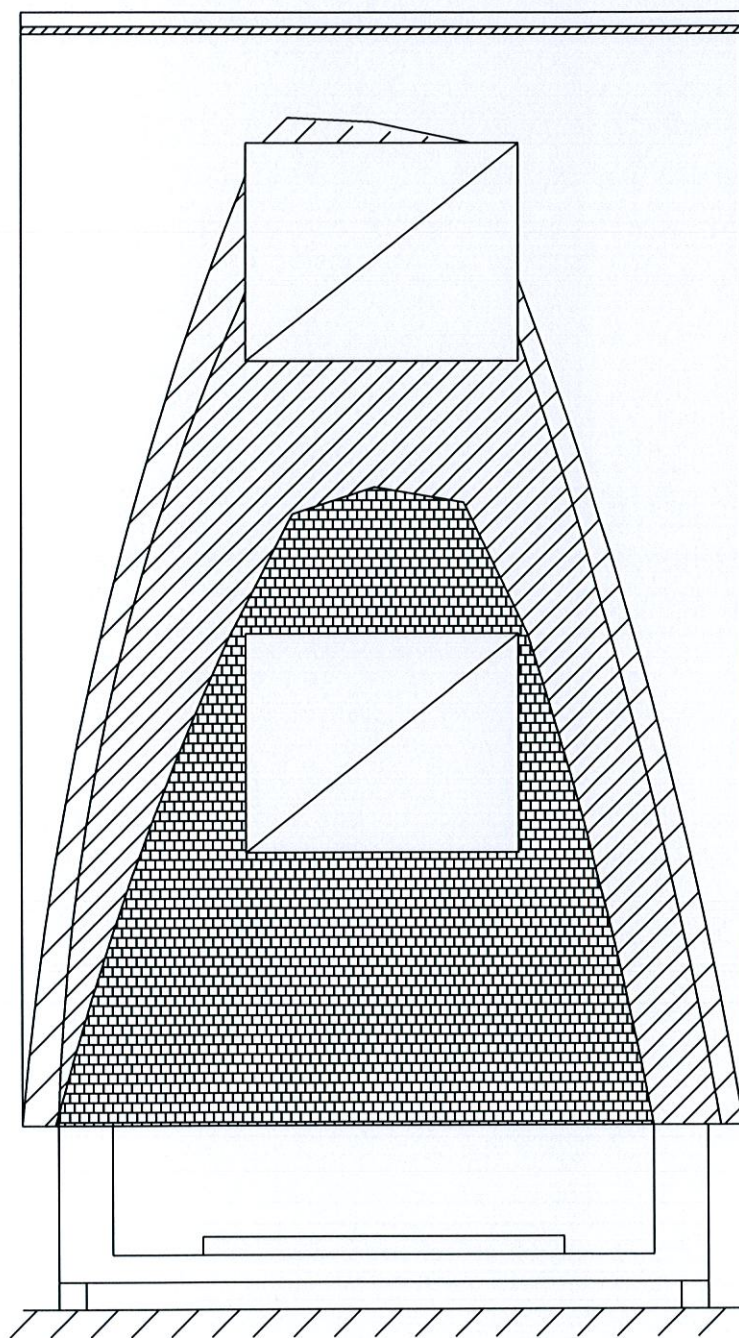
The lower edge of the façade and the area under the lower fictitious window are heavy charred. The drip strip mould along the lower edge and under the lower fictitious window of the test specimen is heavy charred. The area between the fictitious windows is charred. The left side of the drip strip mould above the fictitious window was very little burned. The colour had risen up on the upper drip strip mould on top of the fictitious window and on the architraves on the sides of the fictitious window and been affected by the fire which gave the surface a charred appearance.

The boarding is uninfluenced
-

The boarding is discoloured
-

The boarding is charred
-

The boarding is heavy charred

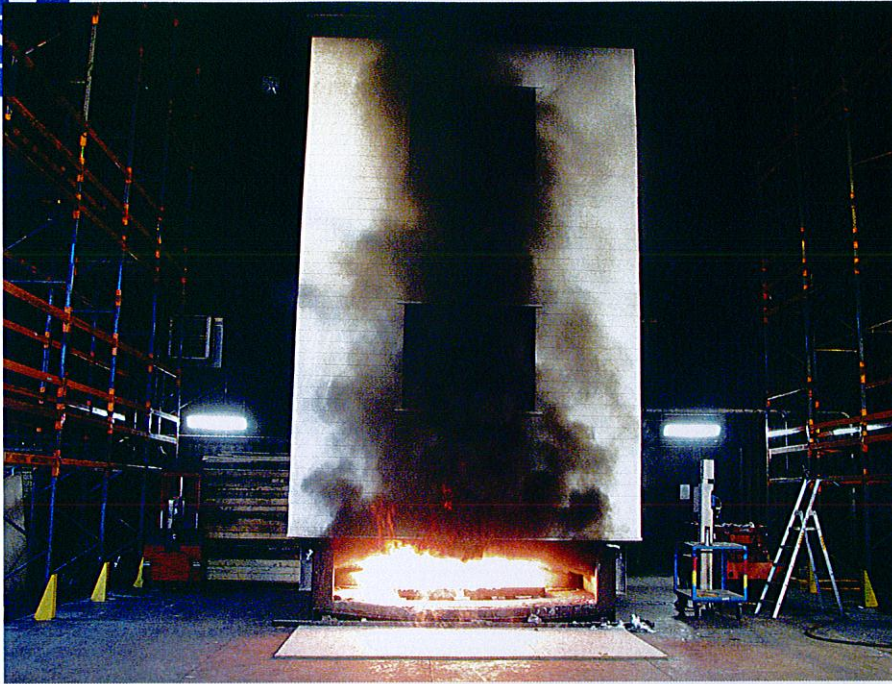
Photo No: 1

The test specimen at the beginning of the test.

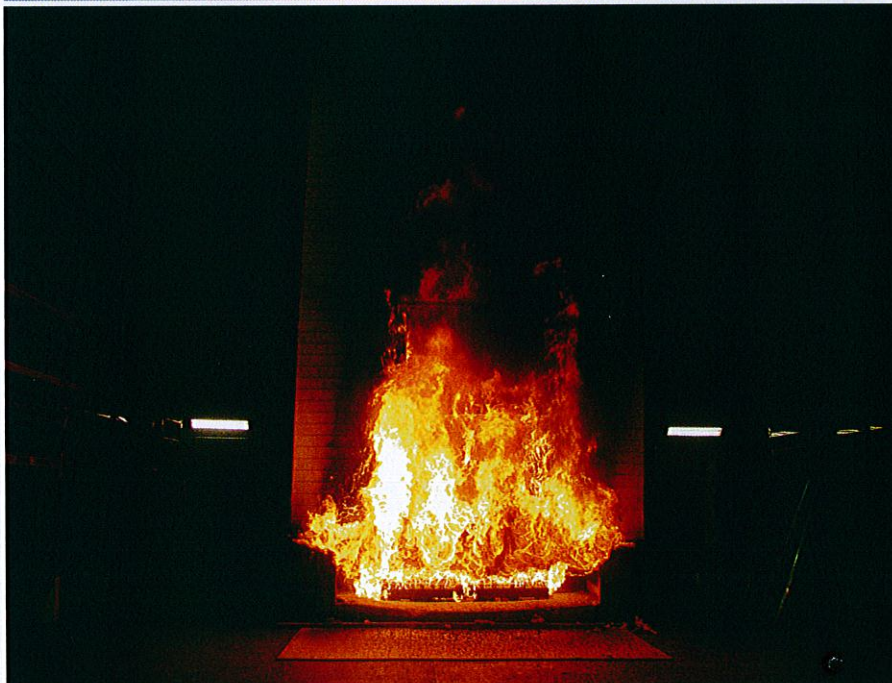
Photo No: 2

The test specimen when the flames reach the lower edge of the upper fictitious window.

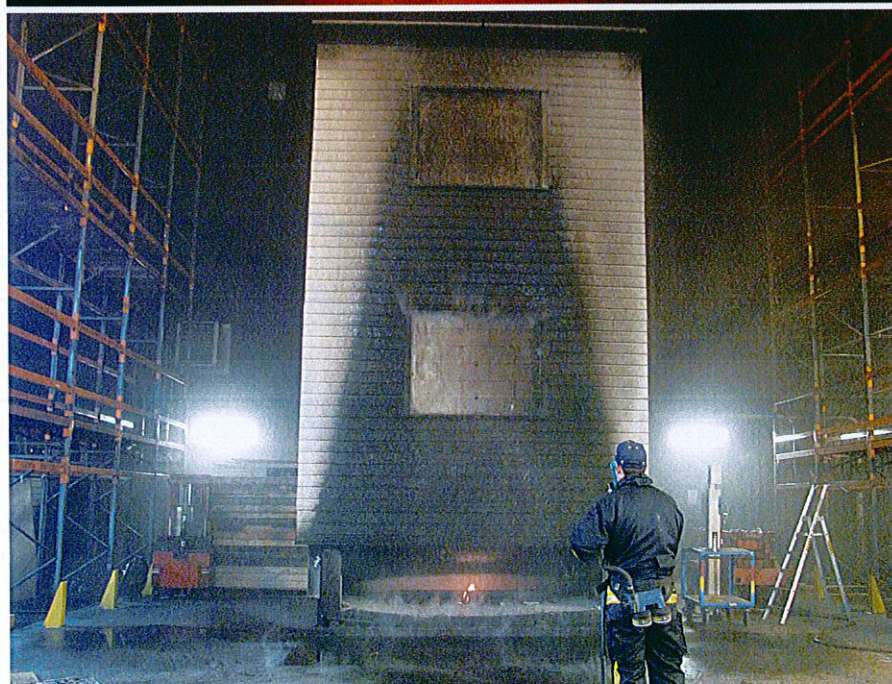
Photo No: 3

The fire exposed side after the test.
