WINTER WEATHER

It is not surprising almost 80% of problems related to factory finished joinery result from items manufactured and supplied during winter months.

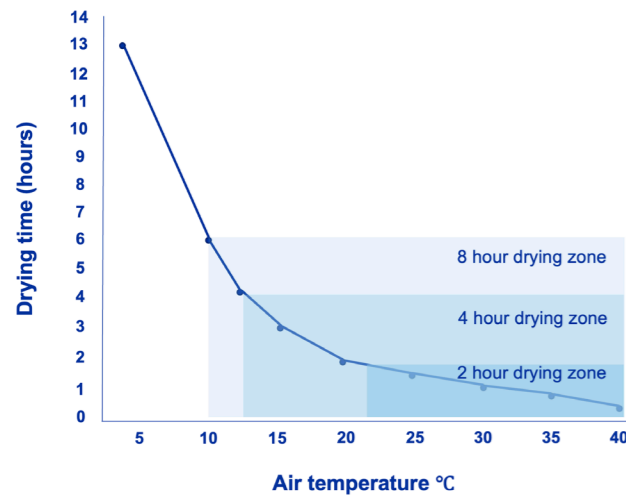
Drying Parameters for Water-based Paint 175µ wft

The graph below shows a typical coalescence curve for water based acrylic paint. At lower temperatures, and with poor airflow, coalescence times are significantly extended, so although the paint may feel dry, it will still hold significant moisture.

Achieving a uniform coalesced film is critical to performance. If water is not removed fully, the film will be disrupted, will not cure uniformly and remain susceptible to moisture, blistering and staining.
