**PERFORMANCE OF THE PAINT SYSTEM ACCORDING TO ISO 12944-6:2018.
 CORROSIVITY CATEGORIES: SALT SPRAY AND WATER CONDENSATION
 TESTS.**

Description of paint system

Trade name	Colour shade	Generic type	NDFT, µm
1 st coat	TEKNODUR COMBI 800-500	white	PUR	120
2 nd coat				
3 rd coat				
4 th coat				
5 th coat				
				Total: 120 µm

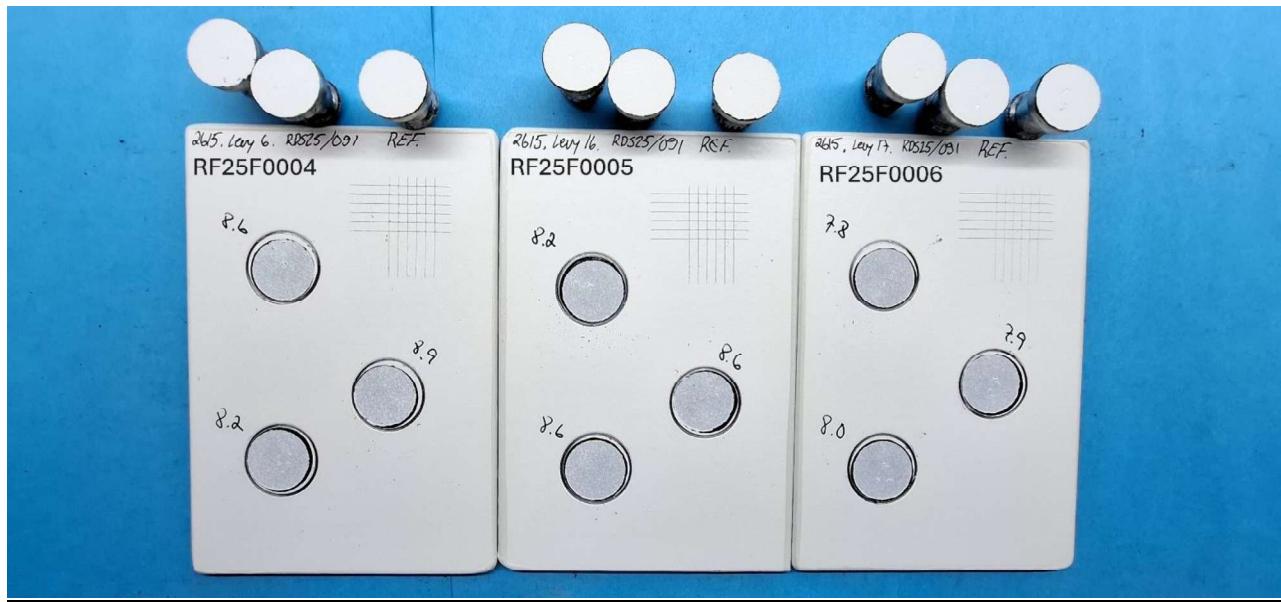
Picture 1. Adhesion reference panels.

Assessment method	Results, panel n:o			Requirements	Remarks
	RF25F0004	RF25F0005	RF25F0006		
ISO 2409, Cross-cut	1	1	1	Classification 0 to 2	Only if DFT ≤ 250 µm
ISO 4624, Pull-off	8.6 8.2 8.9	7.8 8.0 7.9	7.8 8.0 7.9	Min. 2.5 MPa for each measurements	0 % adhesive failure from substrate, unless values at least 5 MPa

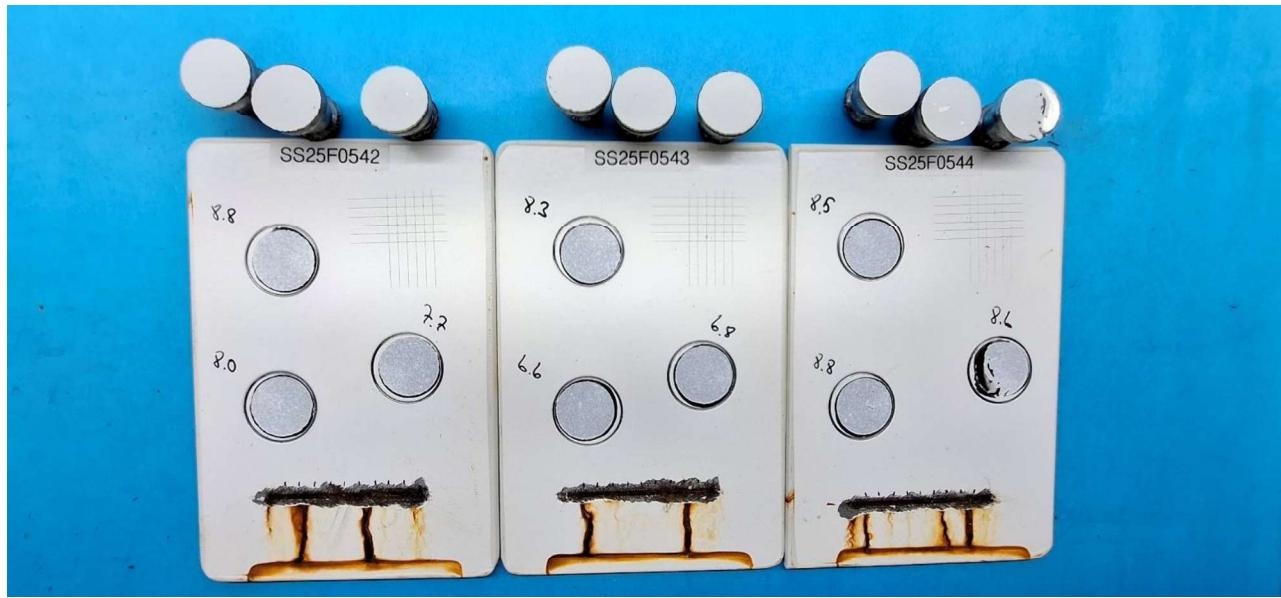
Picture 2. Neutral Saltspray test panels.

Assessment after artificial ageing, ISO 9227: neutral salt spray, test time: 480 h

Assessment methods	Results, panel n:o			Requirements	Remarks
	SS25F0542	SS25F0543	SS25F0544		
ISO 4628-2, Blistering	0	0	0	0 (S0)	
ISO 4628-3, Rusting	0	0	0	Ri 0	
ISO 4628-4, Cracking	0	0	0	0 (S0)	
ISO 4628-5, Flaking	0	0	0	0 (S0)	
Corrosion at scribe	0.1	0.1	0.0	Max 1.5 mm	
ISO 2409, Cross cut	1	1	1	Classification 0 to 2	Only if DFT ≤ 250 µm. Assessment after 7 d reconditioning.
ISO 4624, Pull-off Measurement uncertainty: ± 0,3 MPa	8.8 8.0 7.7	8.3 6.6 6.8	8.5 8.8 8.6	Min. 2.5 MPa for each measurements	0 % adhesive failure from substrate, unless values at least 5 MPa. Assessment after 7 d reconditioning.

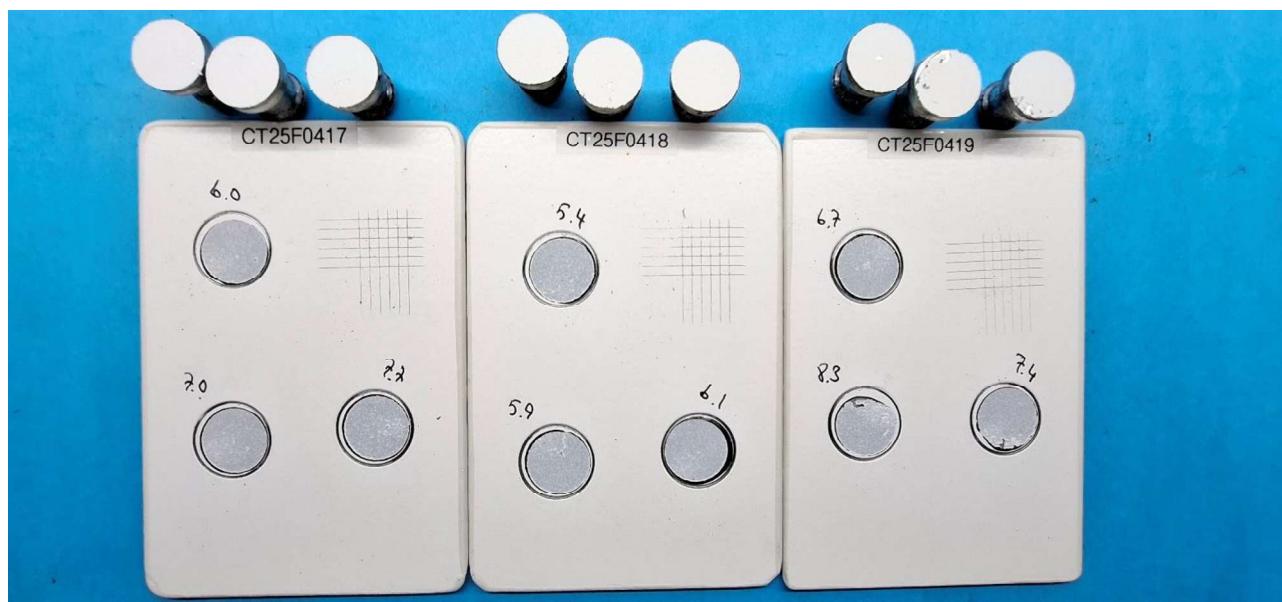
Picture 3. Condensation test panels.

Assessment after artificial ageing, ISO 6270-1: water condensation, test time: 240 h

Assessment methods	Results, panel n:o			Requirements	Remarks
	CT25F0417	CT25F0418	CT25F0419		
ISO 4628-2, Blistering	0	0	0	0 (S0)	
ISO 4628-3, Rusting	0	0	0	Ri 0	
ISO 4628-4, Cracking	0	0	0	0 (S0)	
ISO 4628-5, Flaking	0	0	0	0 (S0)	
ISO 2409, Cross cut	1	1	1	Classification 0 to 2	Only if DFT ≤ 250 µm. Assessment after 7 d reconditioning.
ISO 4624, Pull-off Measurement uncertainty: ± 0,3 MPa	6.0 7.0 7.7	5.4 5.9 6.1	6.7 8.3 7.4	Min. 2.5 MPa for each measurements	0 % adhesive failure from substrate, unless values at least 5 MPa. Assessment after 7 d reconditioning.
