DISCOLOURATION OF COATED WINDOWS & DOORS

TRANSLUCENT COATINGS

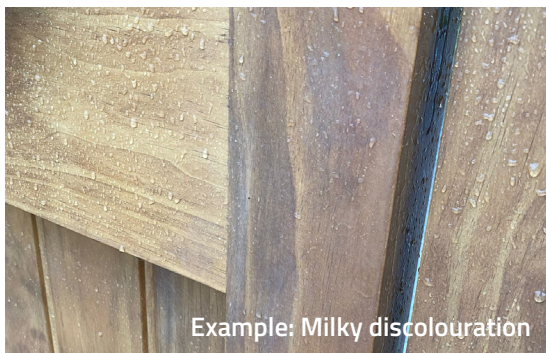
Discolouration of coated joinery is one of the most common site complaints on newly installed factory finished joinery. Milky discolouration in translucent systems can happen in cold conditions when the joinery has been wrapped or is stored in damp conditions. This discolouration will disappear within a few days of the joinery being installed as the residual moisture dissipates into the atmosphere and the coating achieves full cure.

Example: Milky discolouration

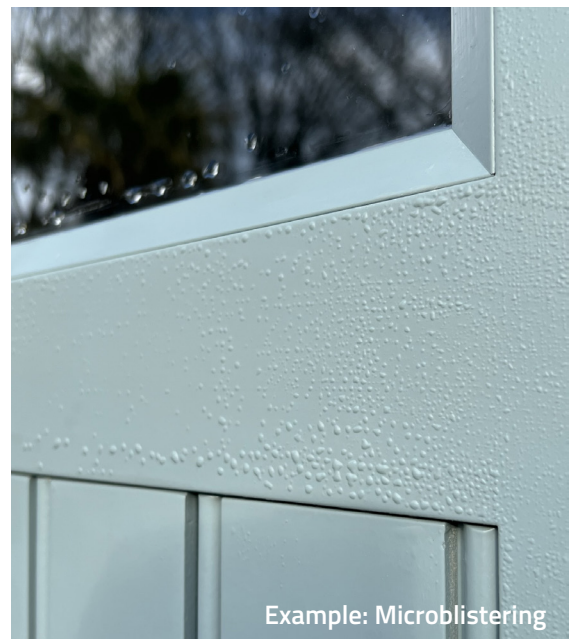
For opaque systems the issue will show itself as micro blistering but in severe cases the blisters can be much larger. Again, these will disappear as the moisture dissipates into the atmosphere.

Example: Microblistering

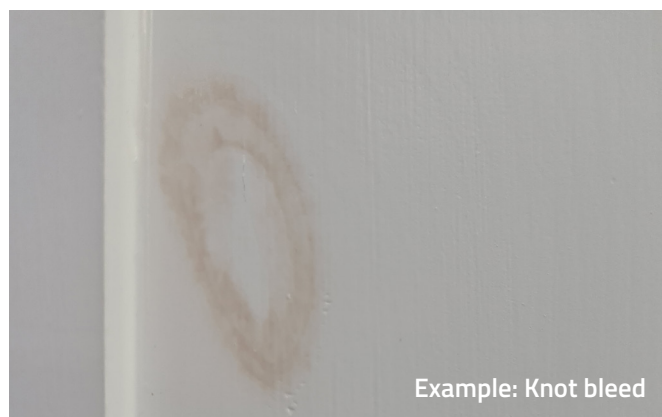
Staining of opaque coated joinery is a more complex phenomenon and generally results from two main sources: soluble extractives or tannins; and resins, both of which are naturally present in timber. Tannins are the main cause of staining in hardwoods, whilst resin exudation tends to be more prevalent in softwood varieties, particularly around knots.

Example: Knot bleed

For softwood that contains knots the 1 component isolation primer is ANTISTAIN AQUA 5210-00, which minimises yellowing from knots and hearthwood inlet.

The best possible reduction of yellowing is achieved with the 2 component solution ANTISTAIN AQUA 5300 in either white or colourless version.
